FOOD STORAGE WAREHOUSE

Seattle, WA

January 5, 1995

FIRE INVESTIGATIONS

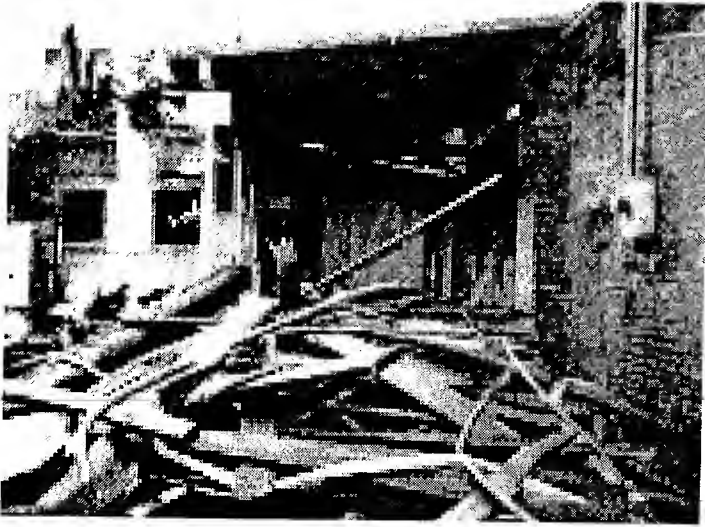
Photograph of the exterior loading dock through which Engine 2 forced entry into the building. Photograph by NFPA.

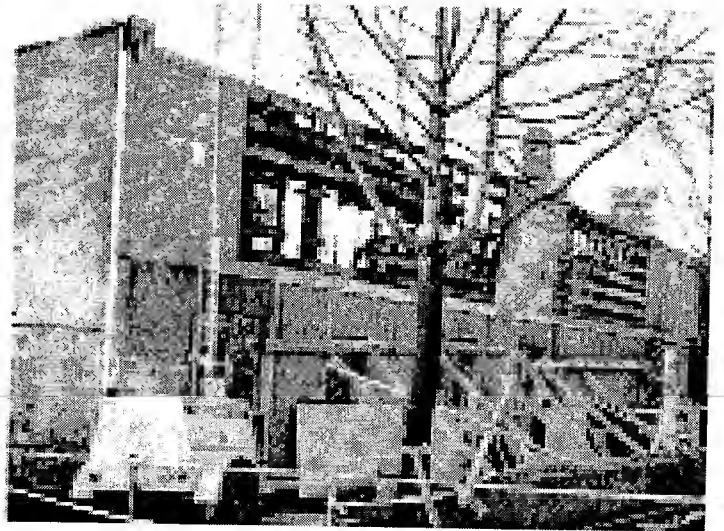
View of the east side of the building as taken from the corner where Engine 10 was staged. Photograph by NFPA.

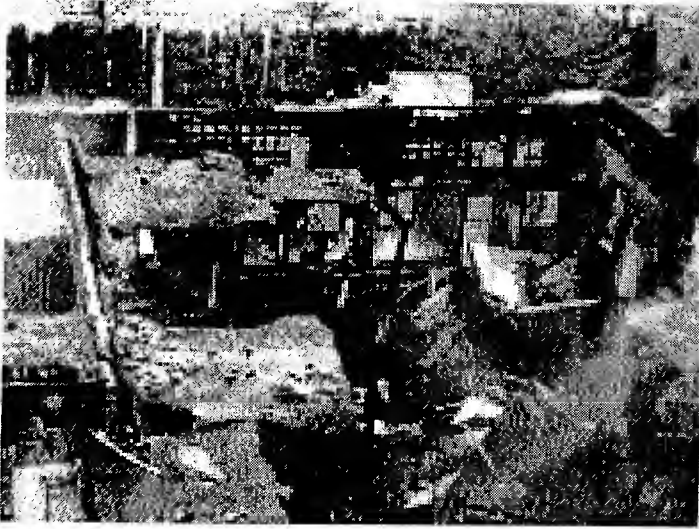
In its subsequent analysis of the incident, the Seattle Fire Department determined that the building had been significantly modified in the area where the collapse occurred. The structural elements of the southeast occupancy were predominantly large timbers that supported the floor joists. Where the joists butted up against the brick wall separating the southeast and northeast occupancies, however, a cripple wall made of 2 inch x 4 inch studs had been constructed. This wall rested on a ledge in the brick wall. When the fire burned through the smaller elements of the cripple wall, the floor it supported collapsed causing the four fire fighters to fall into the area below.

Aerial view (taken from the northwest) of the two story, southeast occupancy in which the collapse occurred. Photo provided by the Seattle Fire Department.

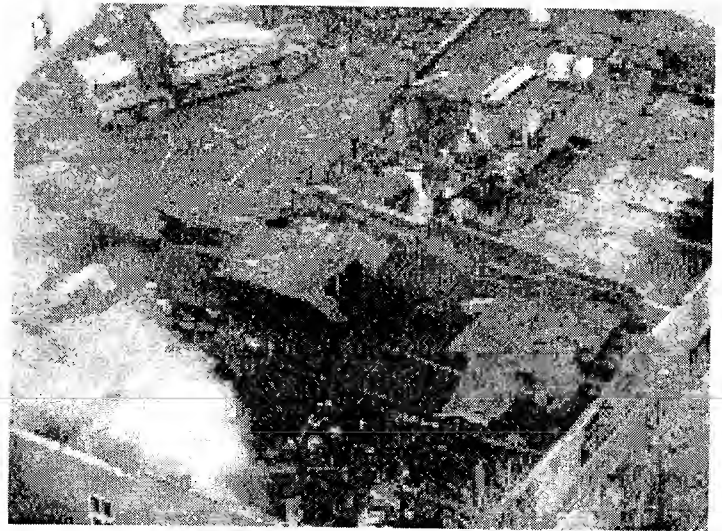
Aerial view (taken from the southeast) of the two story, southeast occupancy in which the collapse occurred. Photo provided by the Seattle Fire Department.

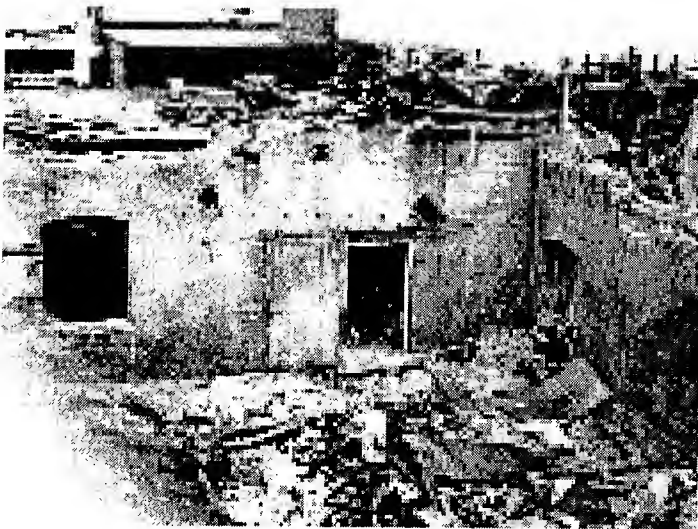
Photograph of the two story, southeast occupancy where the collapse occurred. taken from Charles Street, facing towards the northwest. The sliding fire door seen in the center of the photograph is the door through which Engine 2 observed a large, free-burning fire on the ground floor. Photograph by NFPA.

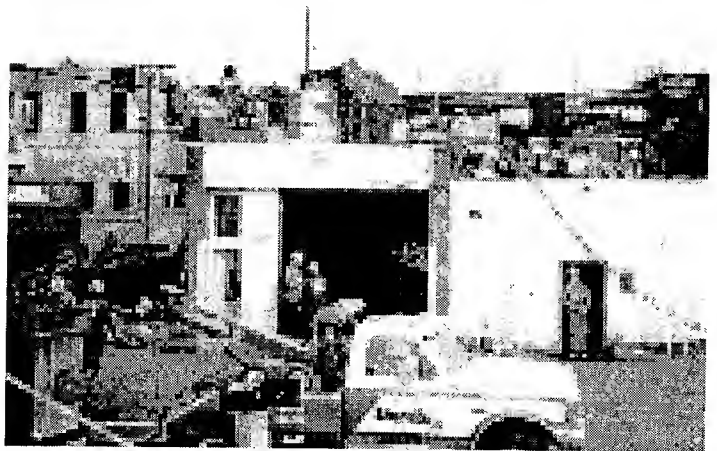
Ground level photograph of the southwest, one story occupancy which housed a bakery and an interior loading dock. Photo by NFPA.
